W7500P Errata Sheet

Erratum 1

Transmission Delay Case

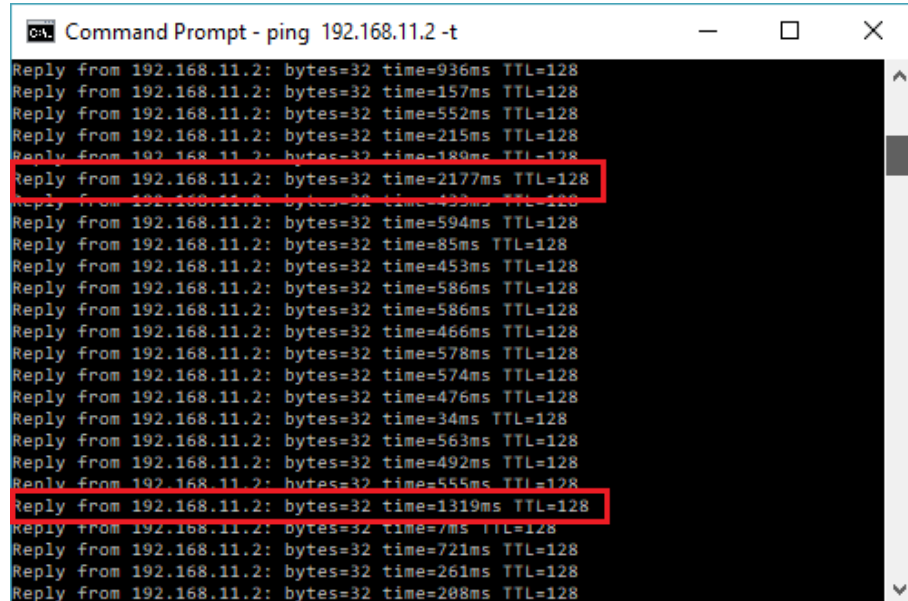
There are some cases of data transmission delay when W7500P is connected to a particular switch or router. (The router that was used for the below test is "TP_LINK AC750")

As shown above, there are random cases where the ping reply is delayed over 3 seconds and occurs irregularly.

The cause of this phenomenon is due to NC(Not Connected) pads & the connection problems related to PHY MII signals inside the chip (W7500P is silicon-in-package product and it includes W7500 and Ethernet PHY circuit inside.); By Collision handling due to wrong detection of duplex mode, the transmission packets are delayed.

In order to resolve this phenomenon, users **MUST** add the following initialization code.
