W3150A+/W5100 Errata Sheet

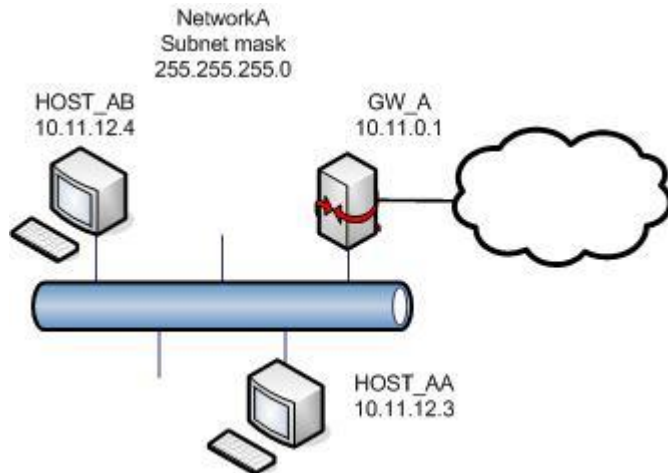
Erratum 1	
Phenomenon	<p>Unable to complete SEND/SENDMAC command in UDP/IP-Raw mode. That is, do not assert SEND_OK interrupt and do not equal the values of Socket n Tx Read Pointer Register (Sn_TX_RD) and Socket n Tx Write Pointer Register (Sn_TX_WR).</p>
Condition	<p>Generally, the Sn_TX_RD value is equal to the Sn_TX_WR value and asserts SEND_OK interrupt when a transmission process was completed. But the case of errata which the Sn_TX_RD and Sn_TX_WR values are different and do not assert SEND_OK interrupt in UDP/IP-Raw mode. This phenomenon is occurred when our chip receive data in opened socket (i.e. assert RECV interrupt) and simultaneously the application program (Host MCU) executes SEND/SENDMAC command on that socket.</p> <div style="text-align: center;">

</div> <p>Figure 1. General network</p> <p>In Figure 1 network,</p> <ol style="list-style-type: none"> 1. Open UDP socket in AA. Port number is 1000. 2. Send UDP data packet(destination port number 1000) from AB to AA. 3. AA processes the UDP data packet from AB. 4. Host MCU in AA runs SEND command to send. <p>When completion of 3 in AA (i.e. AA assert RECV interrupt), AA also runs 4 (i.e. run SEND command). In that case, do not complete process 4 due to errata.</p>

Solution	<p>In case of W3150A+,</p> <p>If you can monitor the RXDV signal (in MII interface), you can solve this problem.</p> <p>Before you execute SEND/SENDMAC command in UDP/IP-Raw mode, check the value of RXDV signal is '0'. That means there is no received data packet, so you can avoid the errata condition.</p> <p>Refer to following pseudo-code.</p> <pre style="background-color: black; color: yellow; padding: 10px;"> /* Change sendto() function */ Function sendto() { ... While (RXDV == '1') ; SEND command; /* Complete Sending */ } </pre>
Recommendation	<p>In case of W5100,</p> <p>We don't have solution but we can give a recommendation.</p> <p>After complete a transmission process, check whether Sn_TX_RD and Sn_TX_WR have same values or not. If both values are still different, close the socket and reset by force.</p> <pre style="background-color: black; color: yellow; padding: 10px;"> /* Change sendto() function */ Function sendto() { ... /* Complete Sending */ /* wait until Sn_TX_WR and Sn_TX_RD are same */ While (Sn_TX_WR != Sn_TX_RD) { wait some time; loop_cnt++; if (loop_cnt > CONST_BLOCK_CNT) goto RESET } } </pre>

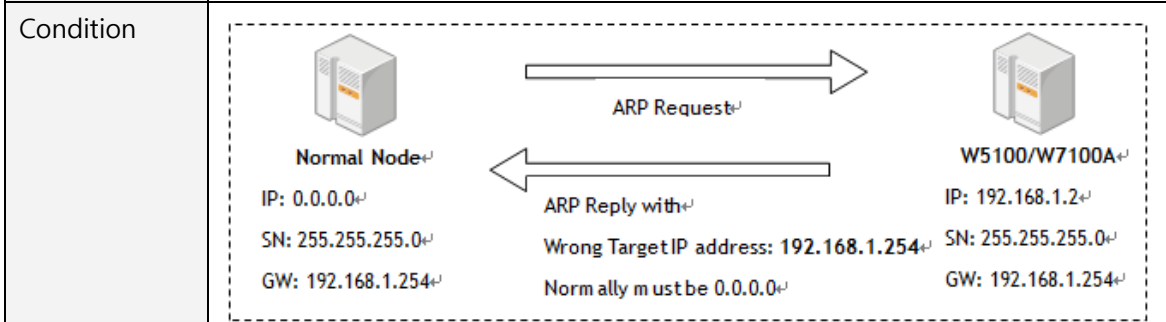
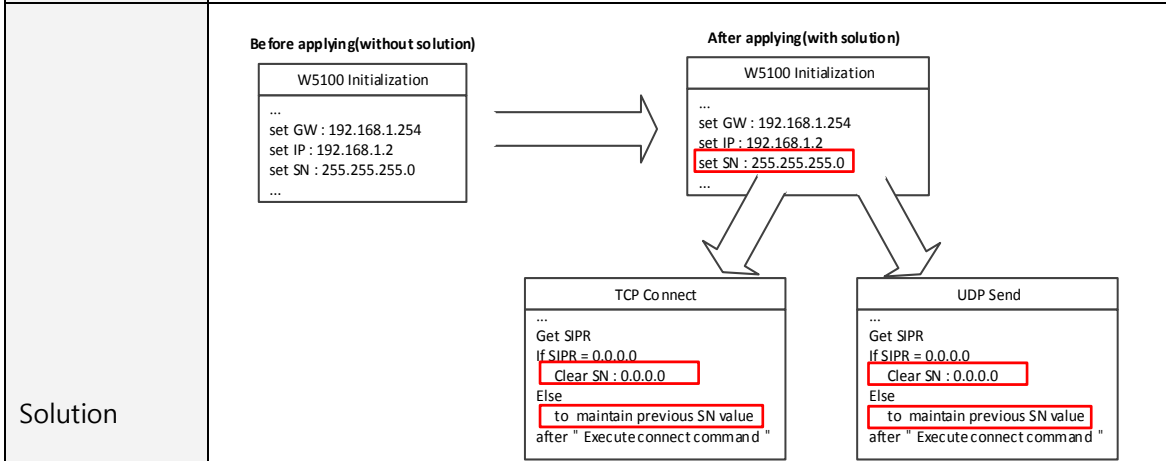
Phenomenon The W5100 replies with gateway IP address for the ARP request from network node which has "0.0.0.0" IP address. But normally the W5100 should replies with target IP address "0.0.0.0" not the gateway IP address.

The main reason of this erratum is subnet calculating logic. The W5100 misunderstands the node locates other sub-network when target has "0.0.0.0" IP address. So the W5100 set the target IP to the gateway IP instead of "0.0.0.0" and sends the ARP reply.

To avoid this erratum we must keep the subnet mask register value to setting value except two cases which are "CONNECT" command in TCP and "SEND" command in UDP. Because only these two cases are referring the subnet mask register and sending the ARP request.

So set the subnet mask register to "FF.FF.FF.xx" and keeping it but save the right subnet mask value to the global variable when you initialize the W5100. When you use connect command in TCP or send command in UDP, set the subnet mask register to zero using the variable before executing connect or

send command. After done connect or send command, sets the subnet mask register again to keep its value to “FF.FF.FF.xx”.

In the case of applying, you can't use the subnet broadcasting.

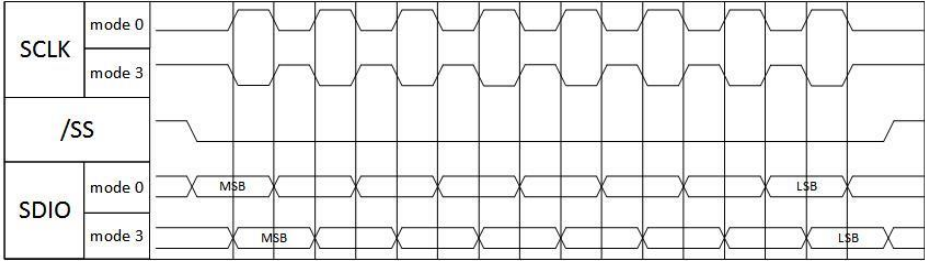
Errata 4	
Phenomenon	Not support SPI mode 3 with a bug
Condition	<p>The documents of W5100 and W3150A+ said that it supports two SPI modes (mode 0, 3).</p> <p>The below figure shows the Timing diagram in SPI mode 0 and mode 3.</p>

<p>But now, W5100 and W3150A+ do not support SPI mode 3 with a bug.</p>
Solution	Not support SPI mode 3
