## W5300 Errata Sheet

Ver 1.1.0 (AUG. 19, 2008)	First release (erratum 1, 2, 3)
Ver 1.2.0 (FEB. 23, 2012)	Add Erratum 4, 5 Change the Errata sheet form (Match with W3150A+ / W5100 Errata sheet.)
Ver 1.2.1(MAR. 23, 2012)	Add a solution for erratum 4,5
Ver 1.2.2 (FEB. 7, 2014)	Add a description of solution for erratum 4
Ver 1.2.3 (MAR. 19, 2015)	Modify a description of solution for erratum 4

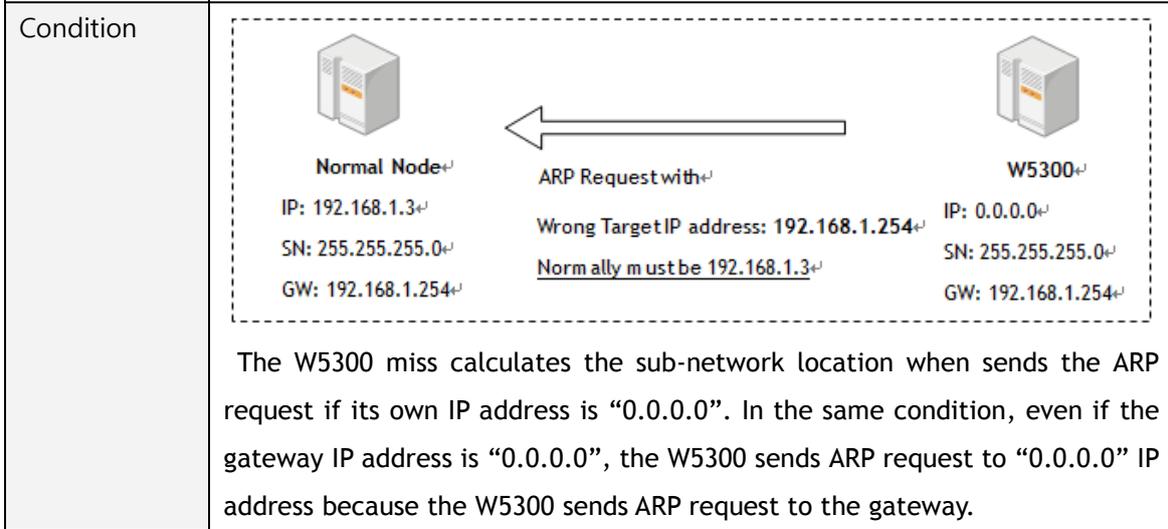
**Phenomenon** Assuming that the IP address of W5300 is “0.0.0.0” and the gateway, subnet mask is valid (not “0.0.0.0”), the W5300 set the target IP address of ARP request to the gateway IP address not the target node IP address when sends ARP request to another node. So the peer node cannot receive the ARP request from the W5300.

**Solution & Recommendation** The reason of this erratum5 is same as erratum4 so the solution is also same with erratum4. Please refer to the solution of erratum4.
